# DINING ROOM

VII

1<sup>st</sup> floor

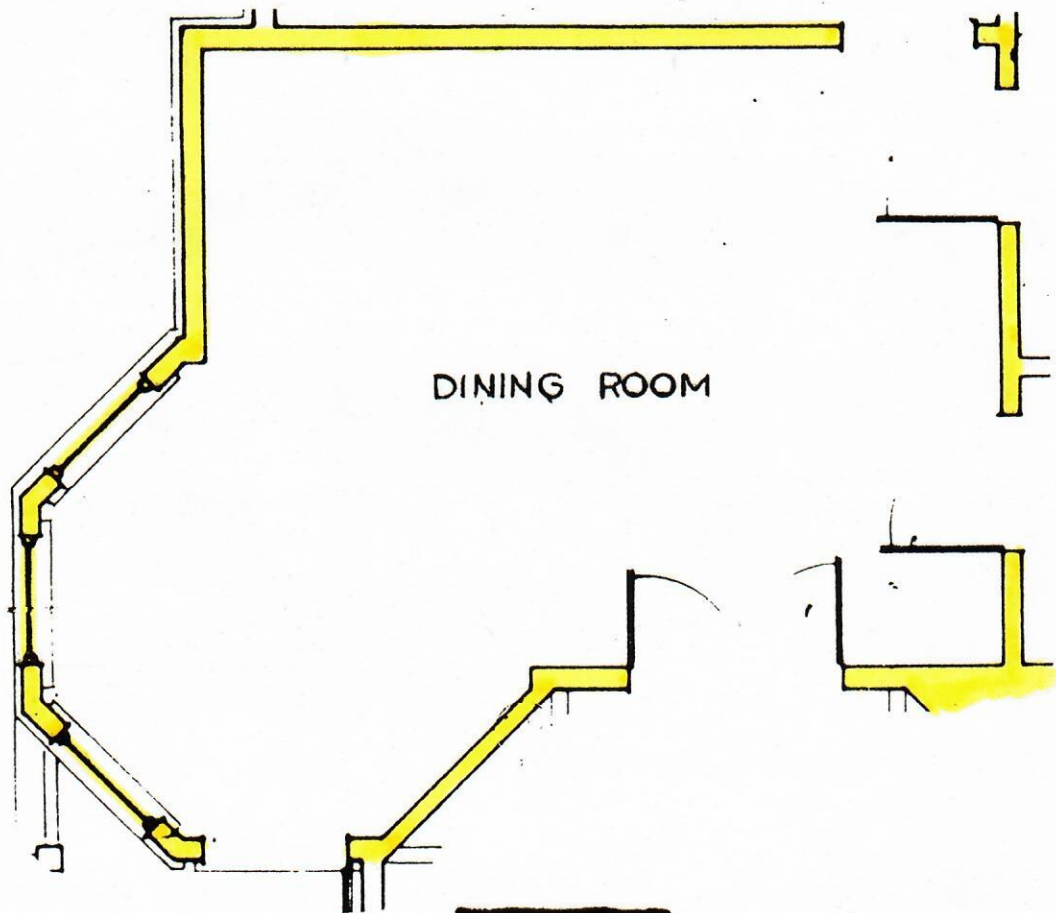
DINING ROOM

## \* Notes: Photos # A-16, 17, 18, 19, 20, 21, 22, 23, 24, 25

- \*1. West wall under the bay window. From the wall to 4 boards out - the 4 boards are  $3\frac{7}{16}$ " wide, the rest of the floor boards in the room are  $3\frac{1}{4}$ " wide. The  $3\frac{7}{16}$ " boards are tongue and groove, whereas the  $3\frac{1}{4}$ " boards are two grooves.
- \*2. The floor boards are  $3\frac{1}{4}$ " wide. See note \*1.
- \*3. The height from floor to ceiling is  $119\frac{1}{2}$ ".
- \*4. The first layer of wallpaper is large white flowers with red leaves. (Flowers look like pointsettias) N #12, #13 - photo taken on west wall.
- \*5. There is a cut border (frieze) on all the walls, except for this one (East wall).

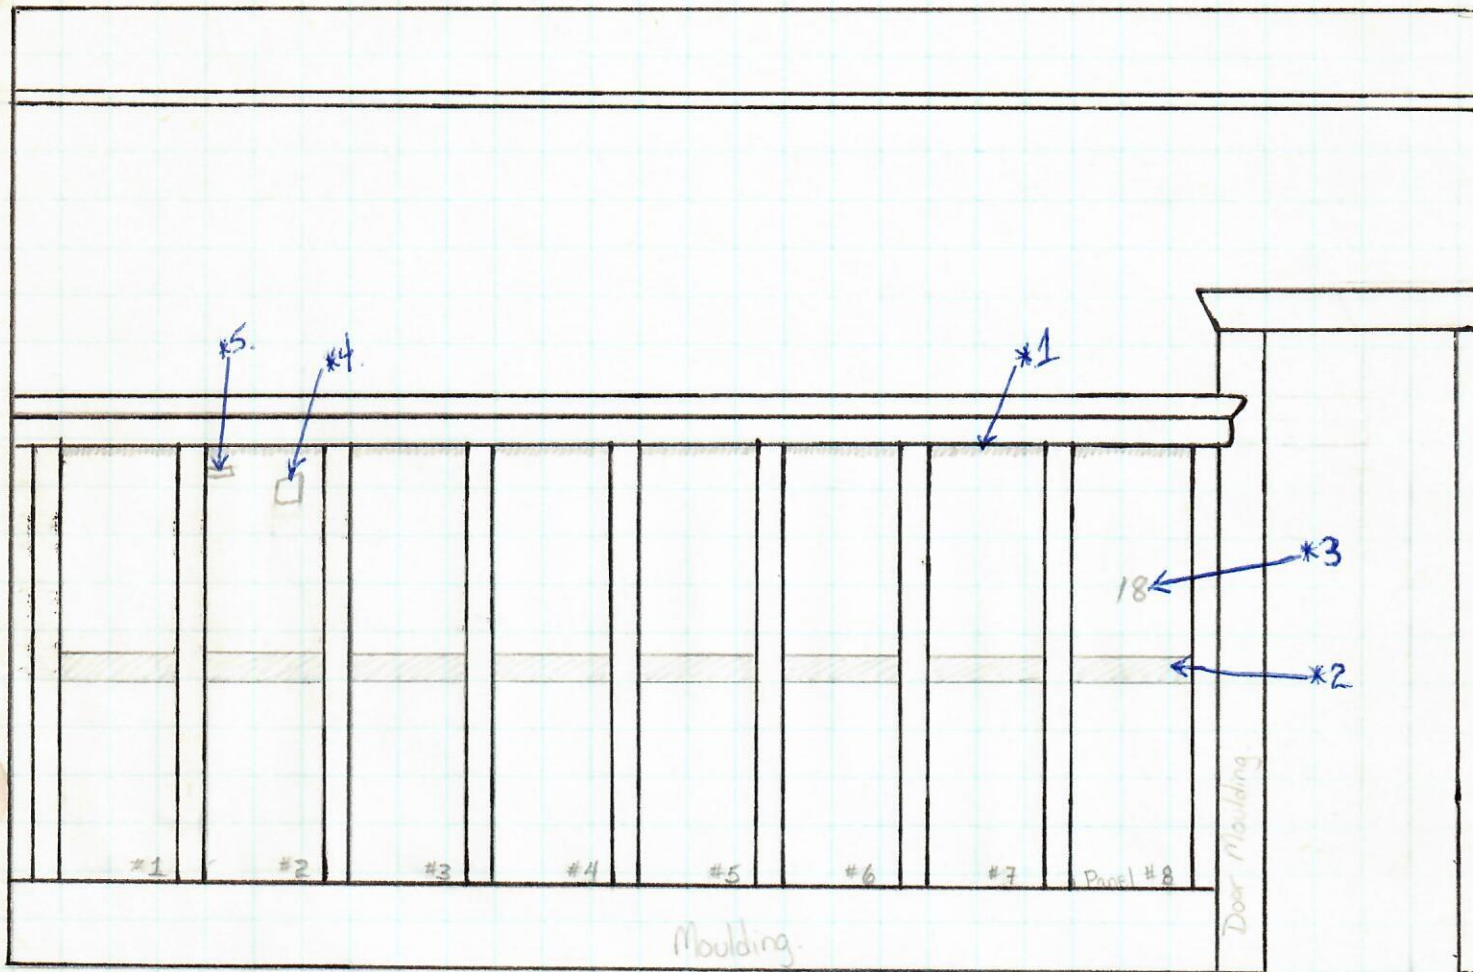
# DINING ROOM - NORTH WALL.

## \* Notes:

- \*1. No paint or plaster coat, just under the mouldings (plate rail).
- \*2. Wood under plaster coat, chair rail markings(?)
- \*3. Number 18 written in pencil on the wall, 4" x 5". P#36
- \*4. Addition (numbers) written on the walls, 2" x 3". Q#1
- \*5. One line, looks like this: 4y 10<sup>th</sup>,  $\frac{1}{2}$ " wide and 2" long. Q#2.

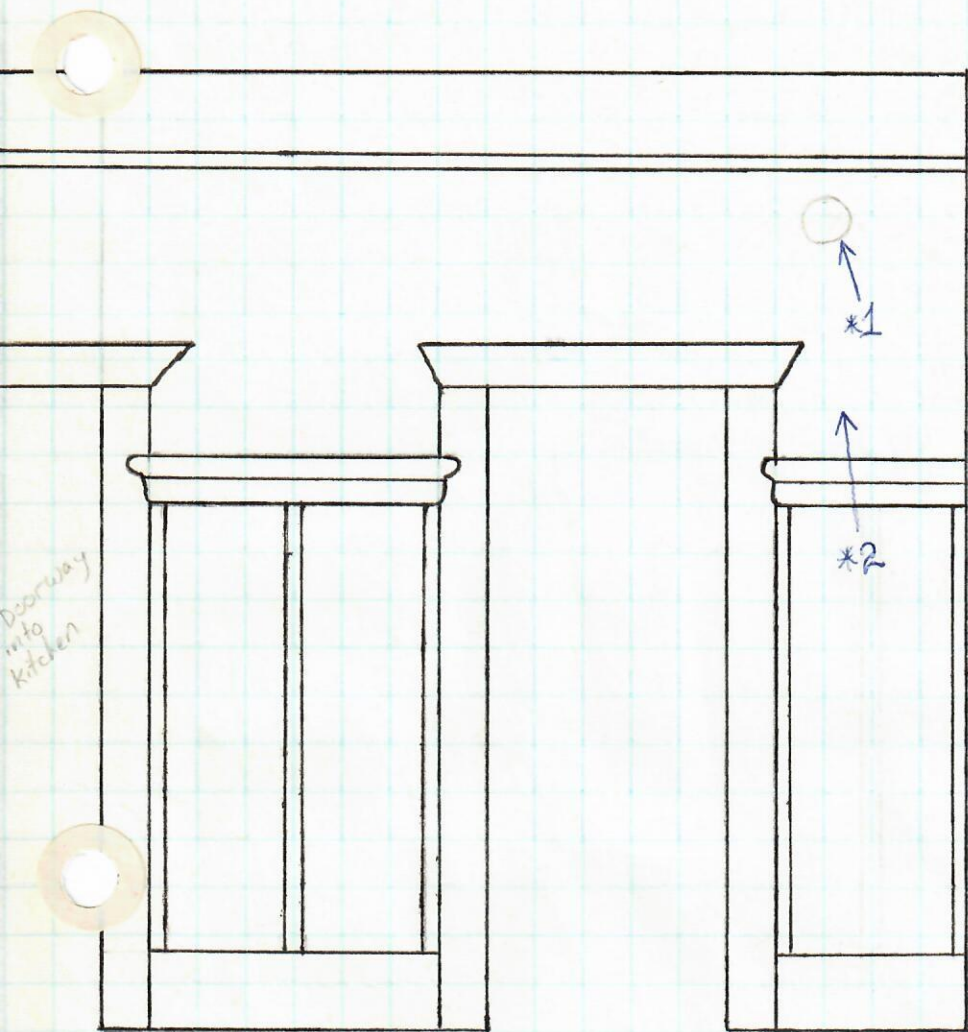
# Dining Room - EAST WALL.

## \*Notes:

- \*1. Plastered hole, goes through to the other side (Plastered on that side too), is 6" wide. **P#34.**
- \*2. The plaster on this wall is very thin, only  $\frac{1}{8}$ " thick. See Stairs and Stair-Hall (XVI) for the other side of the wall.
